### REQUEST FOR PROPOSAL

**BID NUMBER**

735-17-8174

**Demolition Multiple Buildings**

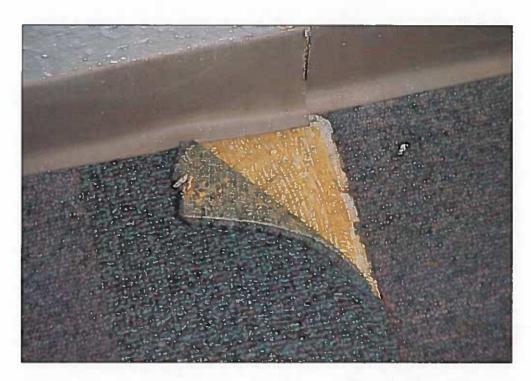
Floor Tile

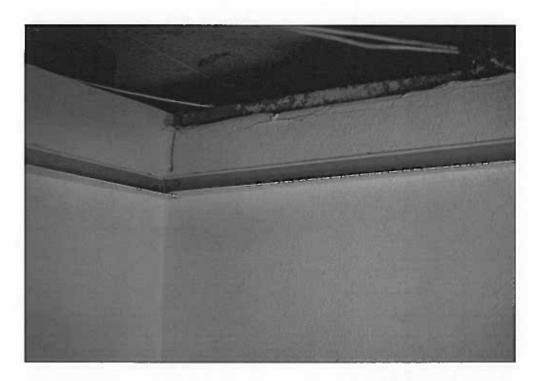
**Sheet Rock** 9 Non-Friable Hazard Rank: 3

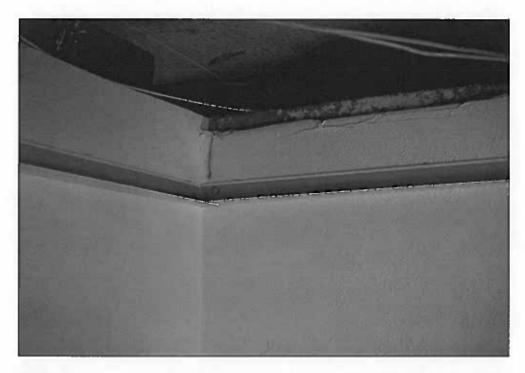
Tape Compound 1

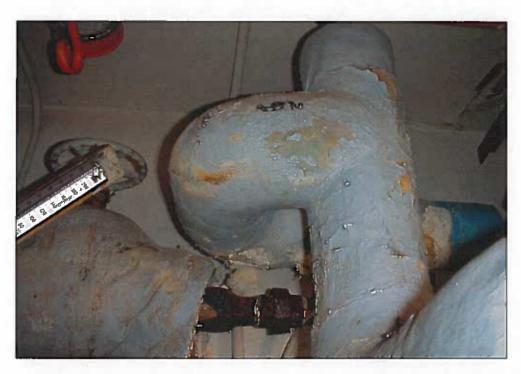
Elbow Wrap 85 Friable Hazard Rank: 5

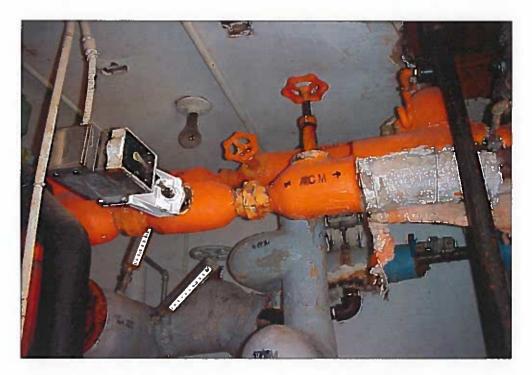
Pipe Insulation 3 - 96 - Friable Hazard Rank: 6

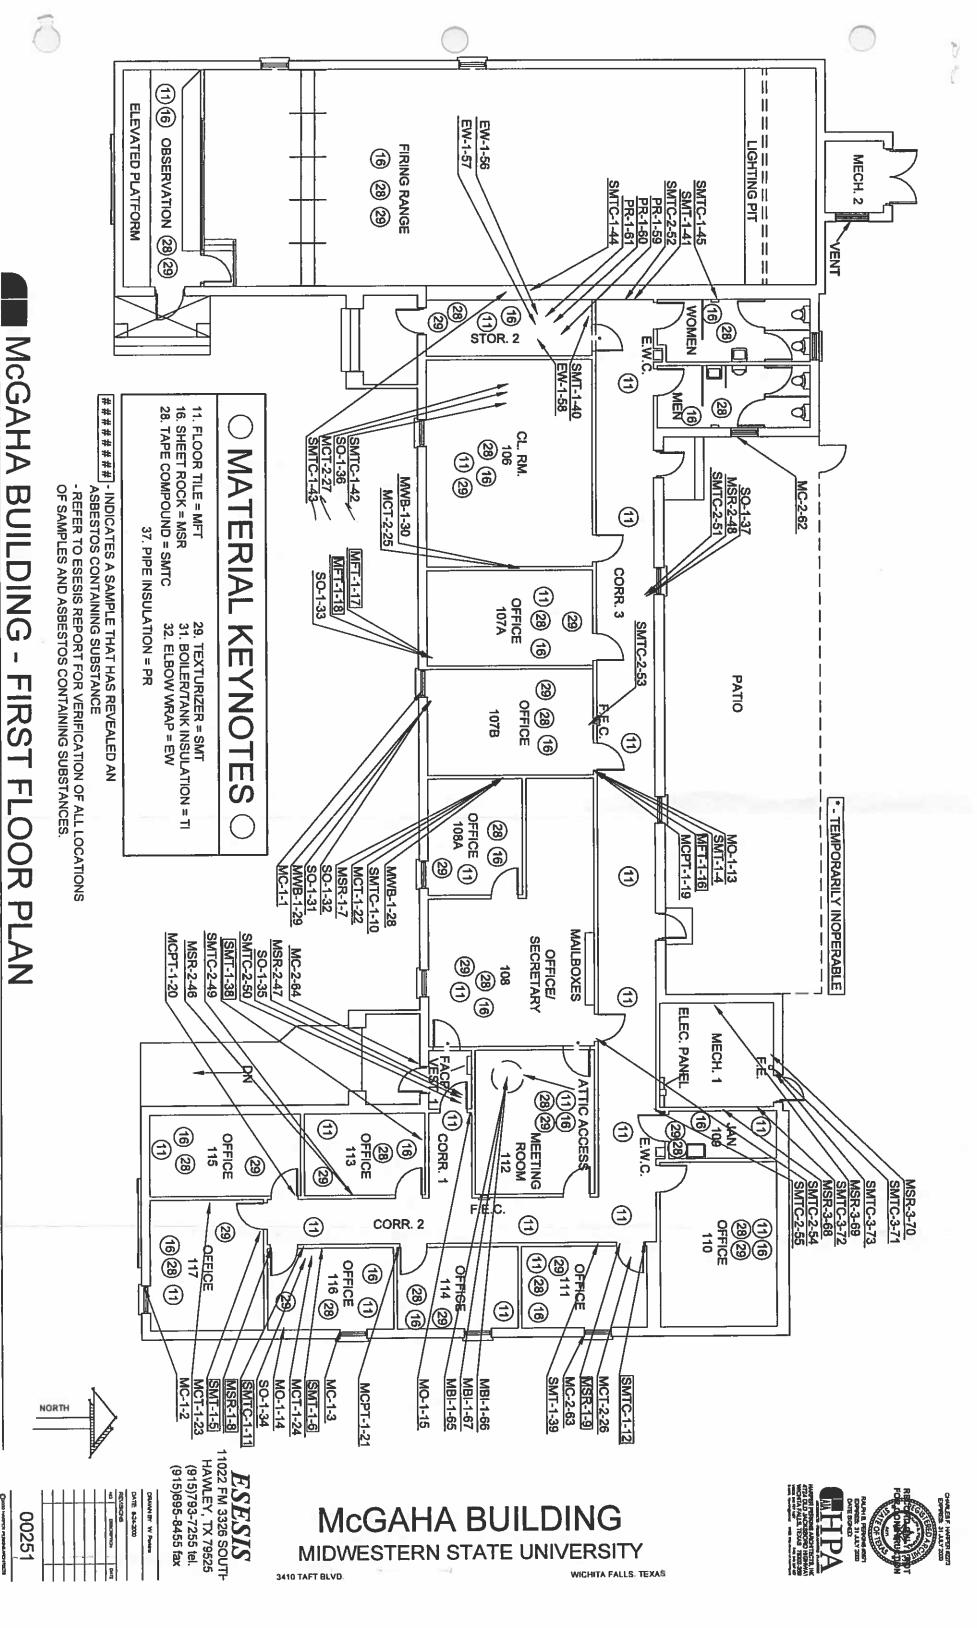
McGAHA 101

SCALE: 3/32" = 1'-0"

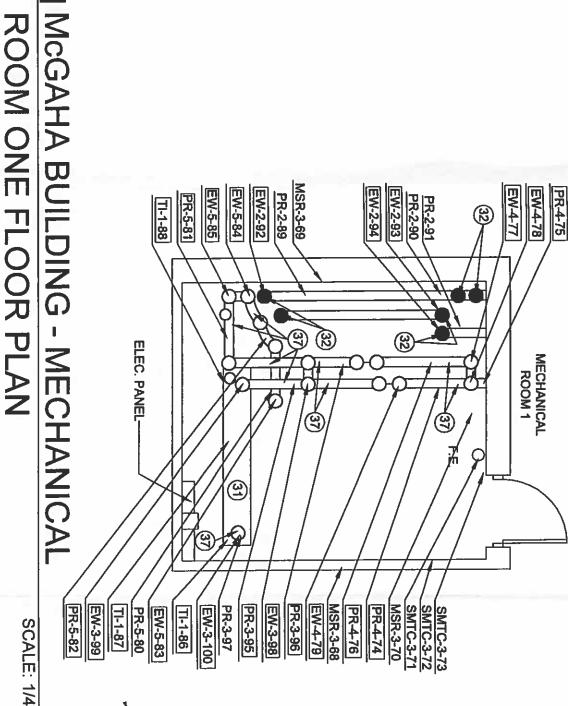
# O MATERIAL KEYNOTES

11. FLOOR TILE = MFT
16. SHEET ROCK = MSR
28. TAPE COMPOUND = SMTC 37. PIPE INSULATION = PR

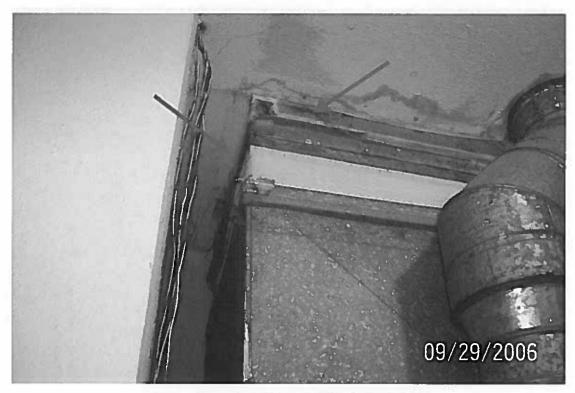
2504 - Asbestos HVAC Tape & Vibration Boot - Note mold growth and water damage from condensation

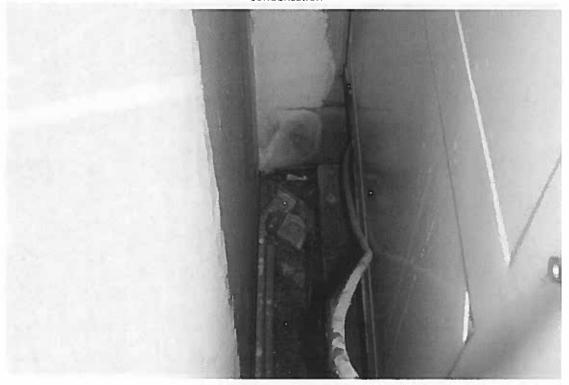
2504 - Mold Growth around HVAC unit

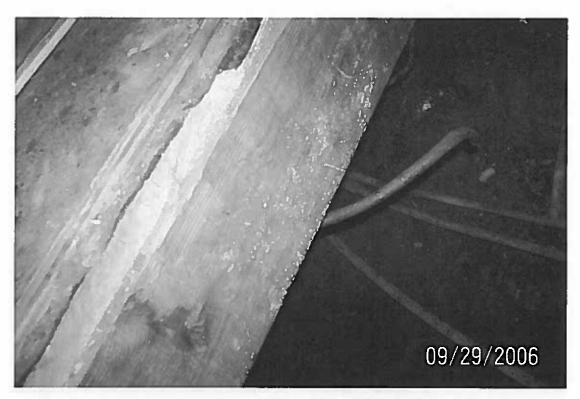
2504 - Mold & Mildew growth on floor joist at hatch

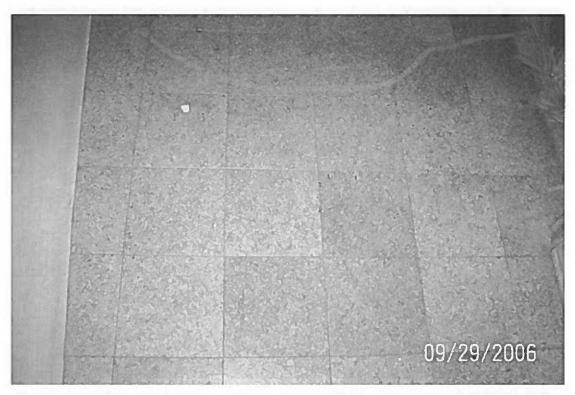
2504 - Cork Flooring

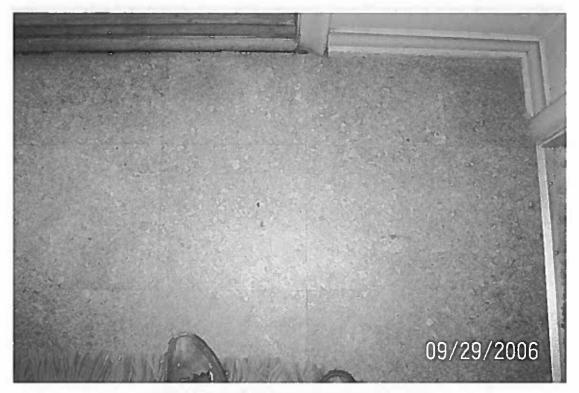
2504 - 12" cork flooring in entrance

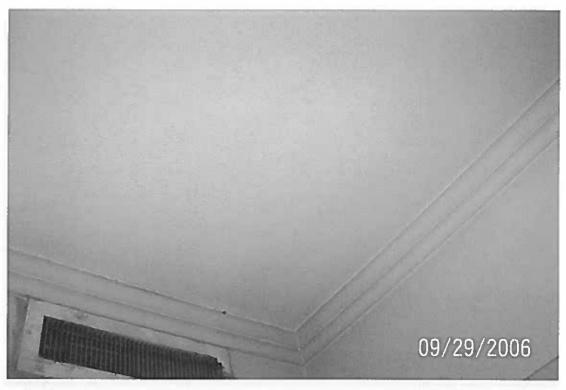
2504 - Finished drywall on walls and ceiling with asbestos containing texture and joint compound

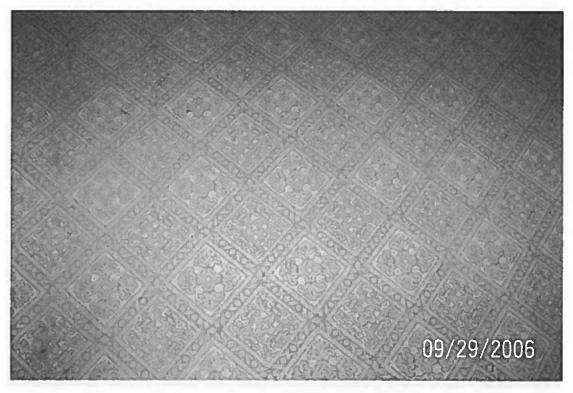
2504 - Asbestos containing sheet flooring in kitchen

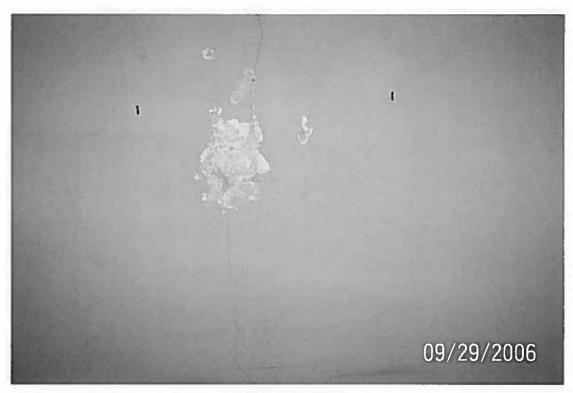
2504 - termite damage in living room that will require repair - removal must be done by asbestos abatement contractor.

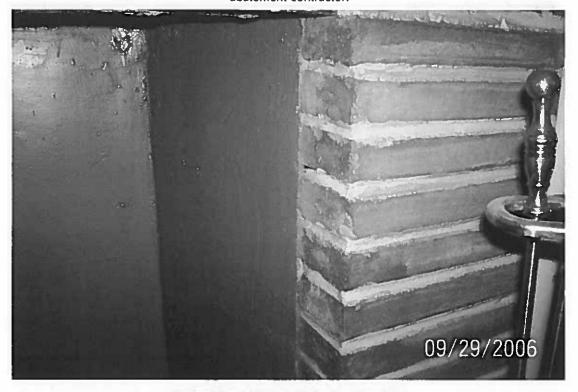
2504 - Plaster and mortar in fireplace

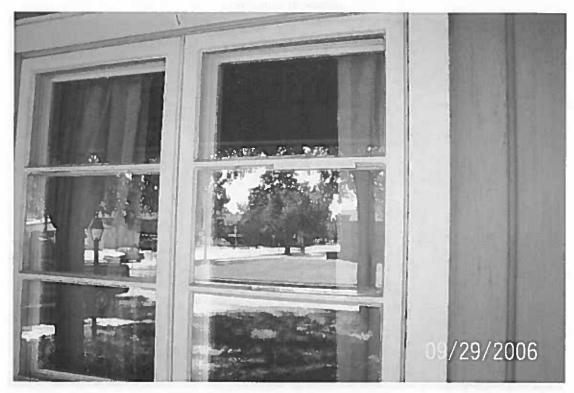
2504 - Window glaze around window panes

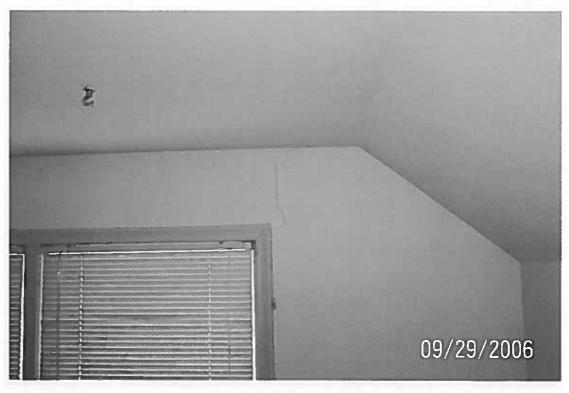
2510 - drywall cracks on 2nd floor

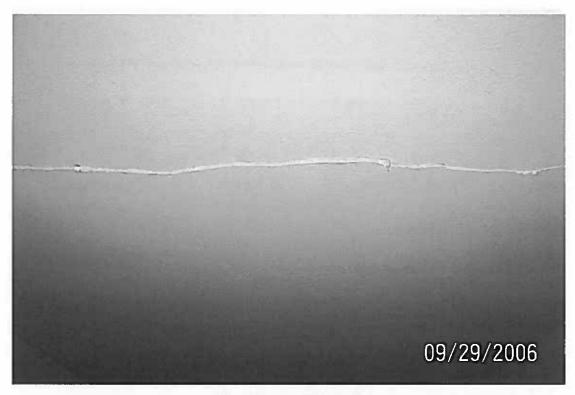
2510 - Drywall cracks on 2nd floor - can be repaired by O&M team with monitoring.

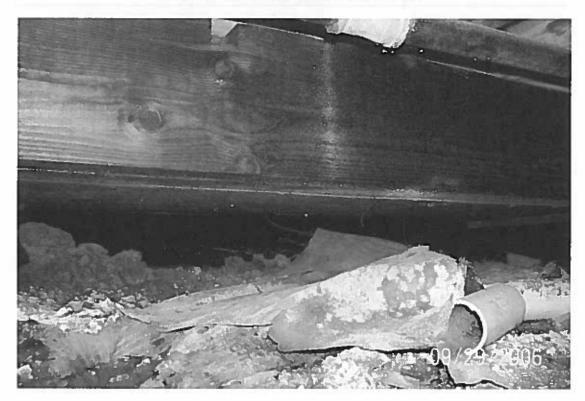
2510 - Views under the floor - note mold growth on debris under the floor
